Shaft vibration analysis by shaft center line method

Abstract: Vibration monitoring methods of most critical equipment like main turbine and compressors always play important role in preventive maintenance and also management consideration in big plants. there are a number of traditional methods like monitoring the overall data from Bently Nevada systems and also the time wave form (TWF) or fast Fourier transform (FFT) monitoring. Shaft center line monitoring method also can play an important role. There are a number of arguments both in favor of and against this method between people who work in preventive maintenance. in this paper I first try to introduce this method clearly and accurately after that I will start to explain a case history that I was in touch directly. during these two steps I try to explain some common mistakes that may accrue by condition monitoring people during the process and sometimes I did it by myself, these mistakes may one of the reasons that sometimes this method seems not effective.

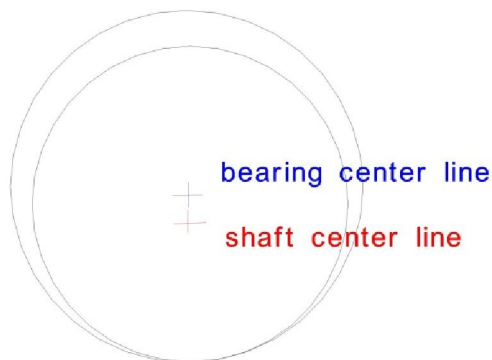
The shaft of the turbine or compressor located in the bearing. the center of the bearing always is in same position because bearing consider as a stationary part after installation but shaft centerline moving in a vertical position. before starting the process of start up for compressor and warming up the steam turbine the shaft centerline is below the bearing centerline that call sleep condition of the main shaft (figure 1).

Figure 1. bearing center line and shaft center line position in shaft sleep condition.

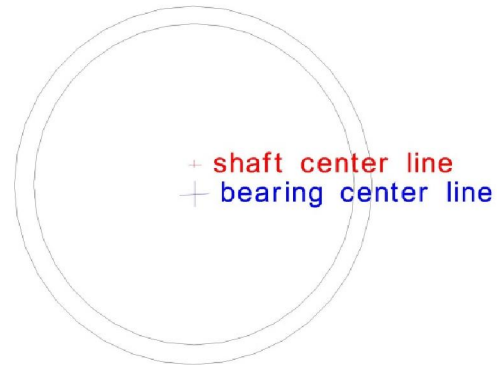
After starting the oil pump of the compressor, this centrifugal pump start to injection the oil to the bearing and the huge shaft of compressor start to moving upward little by little then, the new shaft centerline moving over bearing center line in a vertical line. shown in figure 2.

Figure 2. bearing center line and shaft center line position before operation.

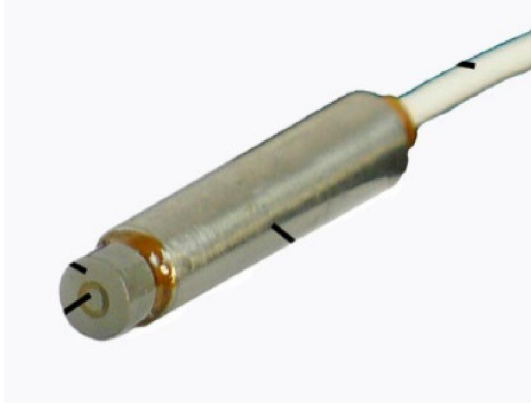
probe is 200 mv/mils called scale factor. it means the probe translate each mils with 200 mv. one mils is unite of distance equal to 25.4 micron usually use in maintenance groups. and mv is equal of 0.001 volt [1].

figure 3. non-contact type probe with 200 mv/mils sensitivity [1]

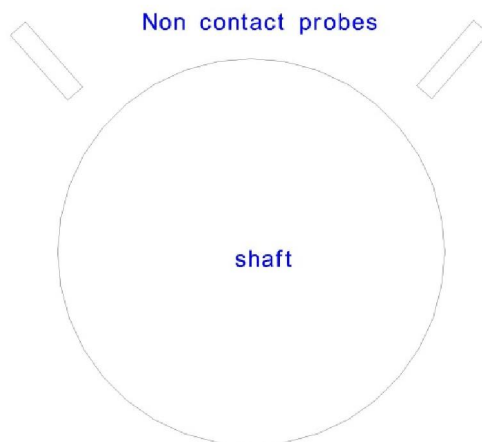
figure4. bently Nevada non-contact probe location.

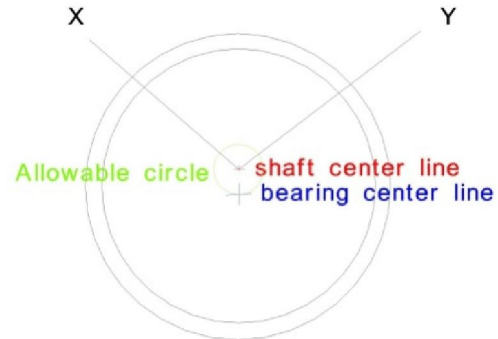
If we introduce X and Y axis in the direction of the noncontact probes then we draw the final circle with the center of shaft center line just before operation (due to the machinery installation) and the radial of distance between shaft center and bearing center. this circle call allowable circle the shaft center line always should be inside the allowable circle otherwise the touch will accrue between shaft and bearing because of geometry considerations. and also the shaft center line position have a direction with the center of this circle this line have a degree with axis Y call attitude angle that should be between 20 to 50 in optimal condition [2].

Figure 5. allowable circle position.

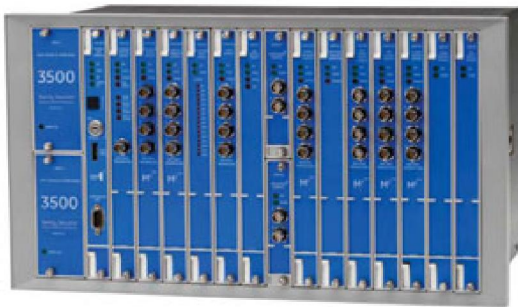
this. The overall vibration measure in micrometer peak to peak (p-p) the alert limit is 20 micron and the danger is 40 then, less than 20 is good and between 20 and 40 is fair then alarm lamp will appear in BNC board in substation (alert condition) and more than 40 is rough condition and compressor will automatically trip to protect the rotary and stationary part of turbo compressor.

figure 6. bently Nevada 3500 series machinery monitoring system [1].

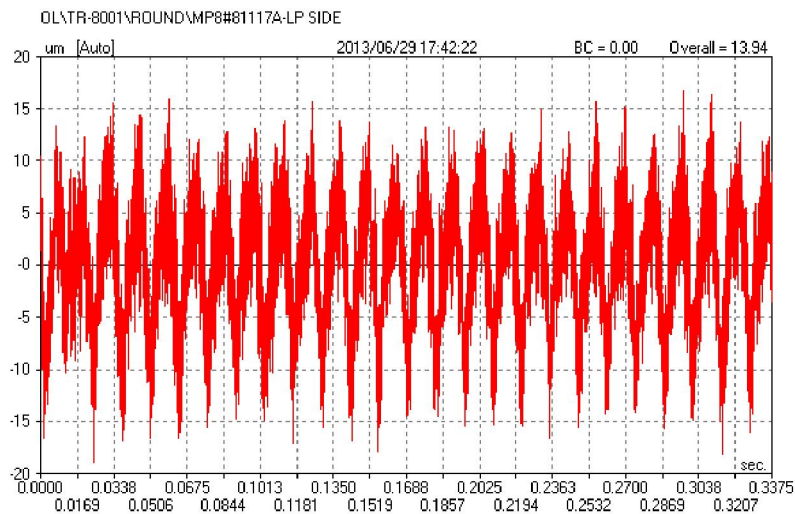
Figure 8. TWF steam turbine low pressure side.

The symmetry still exist also the carrier and high frequency ride wave (modulation) is also like previous signals. these data all related to POINT 2-turbine DE in vertical position the FFT also same as previous signals.

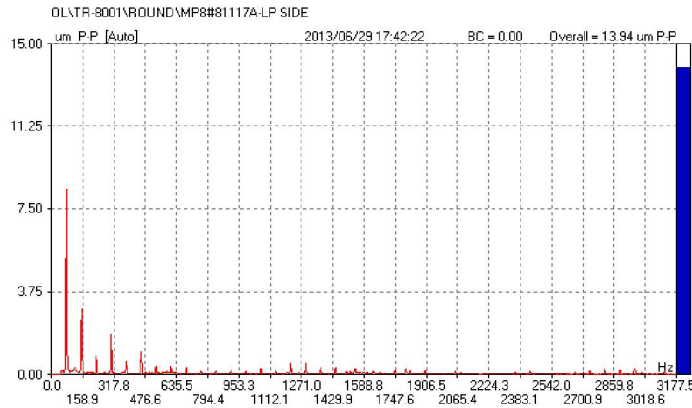
Figure 9. FFT steam turbine low pressure side.

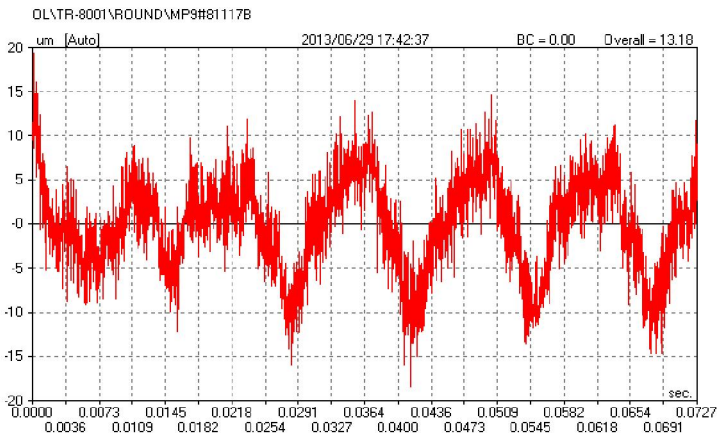
The compressor side TWF show some stronger impact in bearing system but the amplitude of impact not too much to allow us any recommendation for checking bearing systems in point 3. point 4 was

Figure 10. TWF point 3 horizontal direction

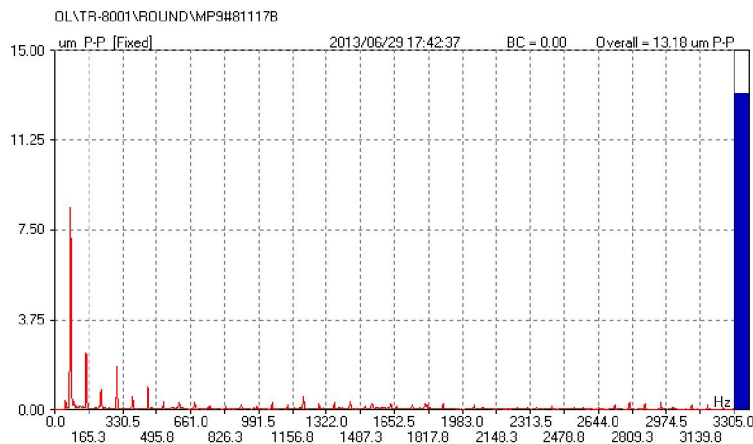
remain steady in shape of both TWF and FFT. also the FFT form remain constant in all position and direction. the first two diagrams related to point 3 horizontal direction.

Figure 11. FFT point 3 horizontal direction

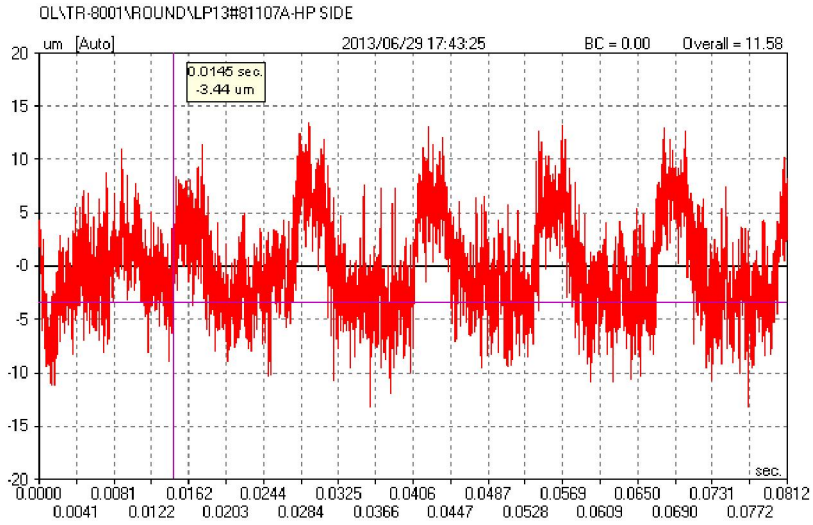
The following two diagrams related to point 3 vertical direction. The cursor can help us to better understanding the scale between time and amplitude.

Figure 12. TWF point 3 vertical direction

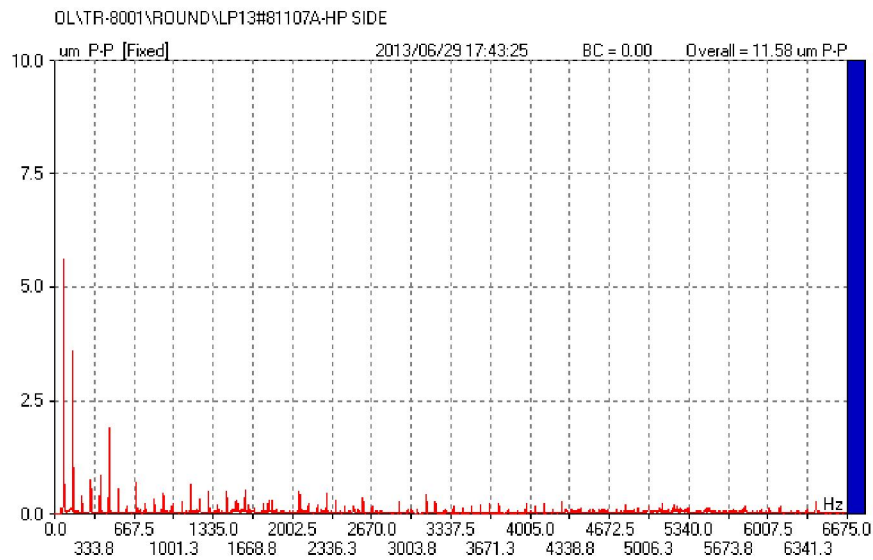
Figure 13. FFT point 3 vertical direction.

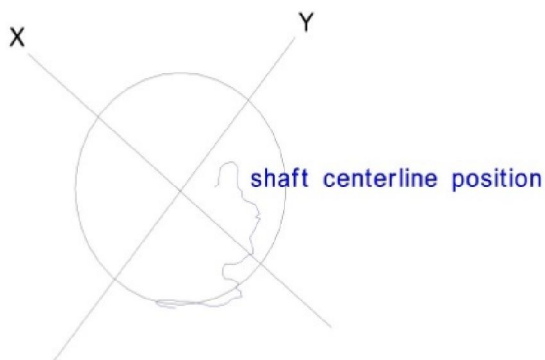
Figure 14. shaft center line position MPC-C-8001.

As we can see in this circle the shaft touch the bearing in the down half of the bearing and the bearing may damage in this condition now we have enough evidence to predict this phenomena and it is mandatory to recommend the operation process department and management to turn of the machine and change the process role of this compressor to the spare compressor simultaneously to continuing the olefin production during maintenance of this compressor. The bearing housing in point 3 consist of a journal and a thrust bearing. the journal is sleeve type and the thrust is tilting pad. after checking the bearings system in point 3. the upper half was ok but the down half was touch and damage seriously. Also the main shaft touch and should be send to metal spray. the bearing should change and reinstall. The down half of bearing shown in these figures:

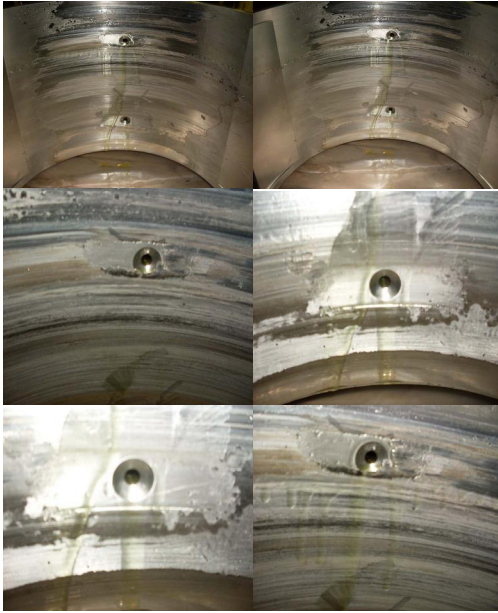
Figure 15. down half of the bearing point 3.

As it is clear from the above photos the bearing condition was very bad and it was in the condition that all traditional signals like overall vibration BNC and TWF, FFT, phase trend, gap voltage trend show nothing abnormal or any dramatic increase but the shaft centerline monitoring provide evidence for recommendation and cause successful predictive recommendation. if CM group did not perform this method the alignment will face problem in next step. the valuable turbine blades may have some touch or damage or some damage will accrue in multi stage compressor parts and pose high economical costing to the factory. also the plant will face an unexpected shut down for several hours. the process may have 4 to 5 hours high pressure work to start up the spare compressor also there are thousands of dollars waste

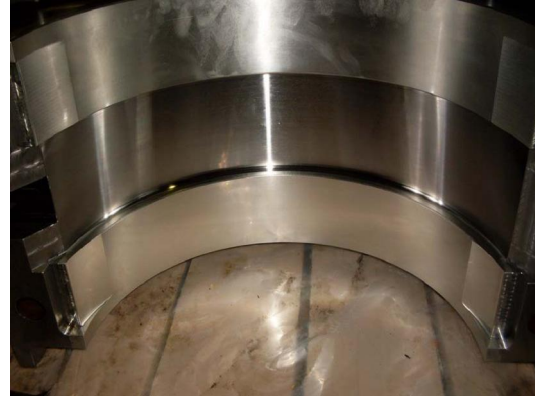
Figure 16. up half of the bearing point 3.

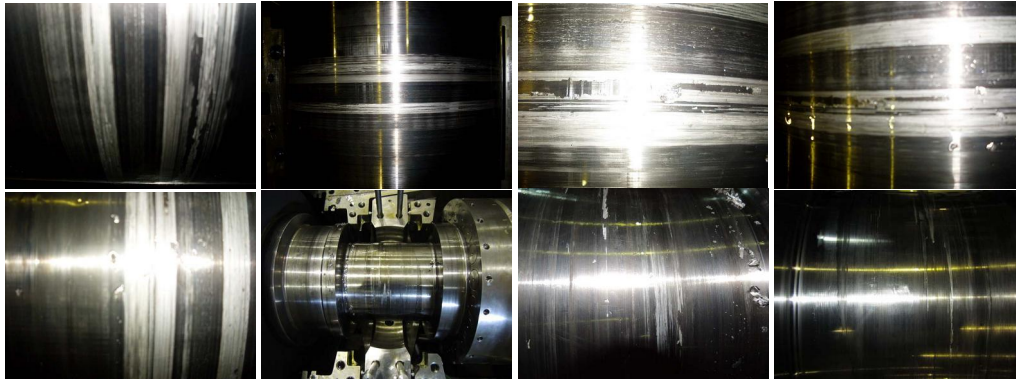
figure 17. rotor and main shaft condition MPC-C-8001.
